Hi, Michael.

Done at last and all works well. Following descriptions are for the images (which are attached and numbered in sequence):

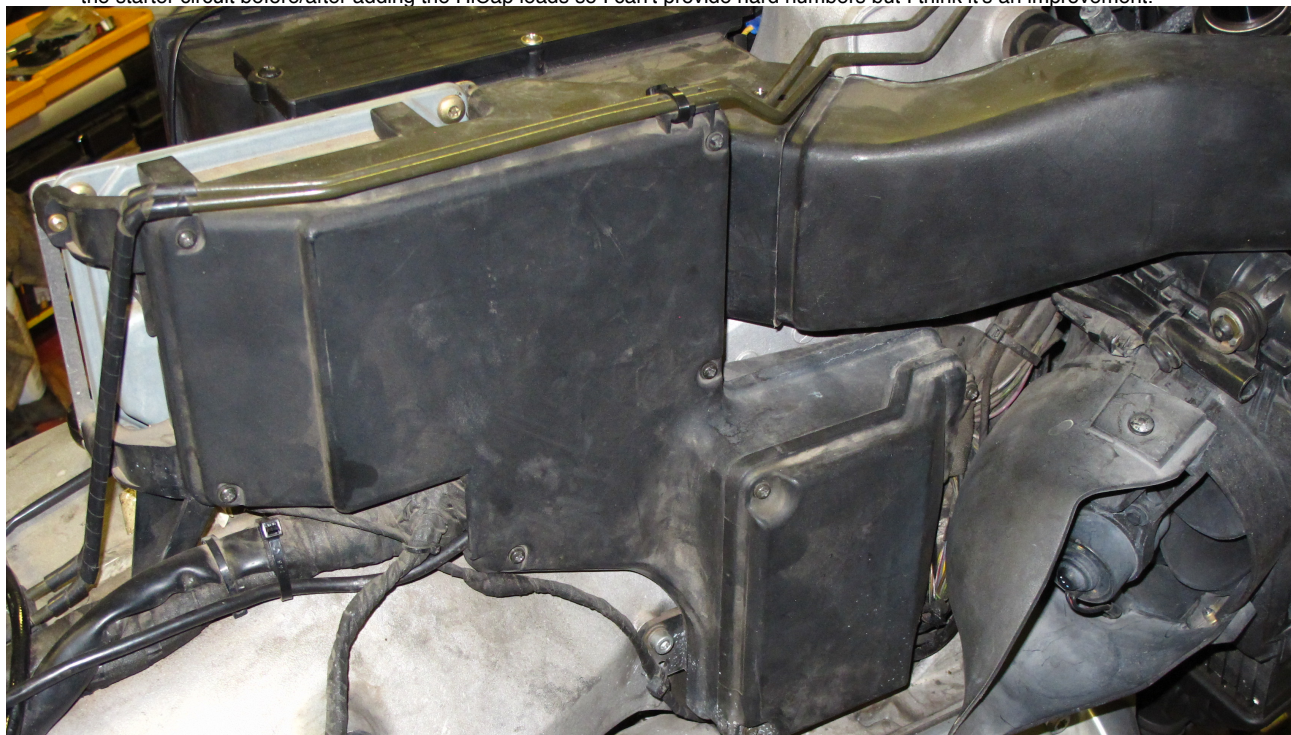
1. Fairing and fuel cell removed. This is the electronic relay center/ECU tower on a BMW '98 K1200RS.
2. Center left is the starter relay with red/black in/out cables attached.

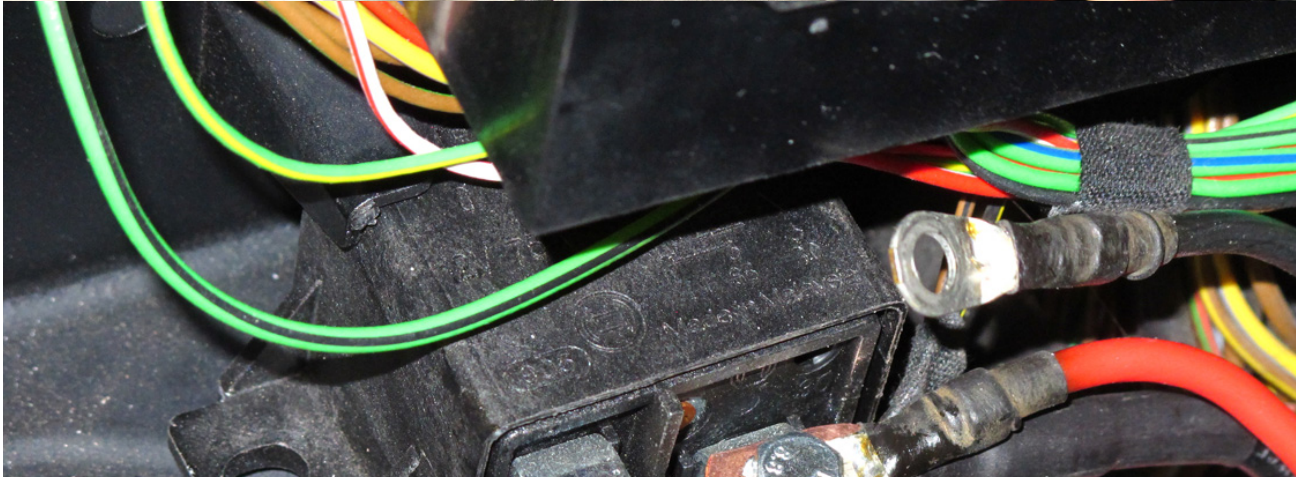
3. Positive cables attached to the relay input. Both the original and the HiCap must be attached. There's room for both.
4. Positive terminal on the starter as seen from under the frame looking up. The coil has been removed, four T25 fasteners, to gain access to the starter. Lower right fastener has a ground lead attached. It's easy to forget to put this back in place. Under the bike reaching up is the easiest way to reach the terminal. HiCap ground is not in place when reaching the starter terminal; it's in the way. HiCap lead is attached to the terminal in this photo.

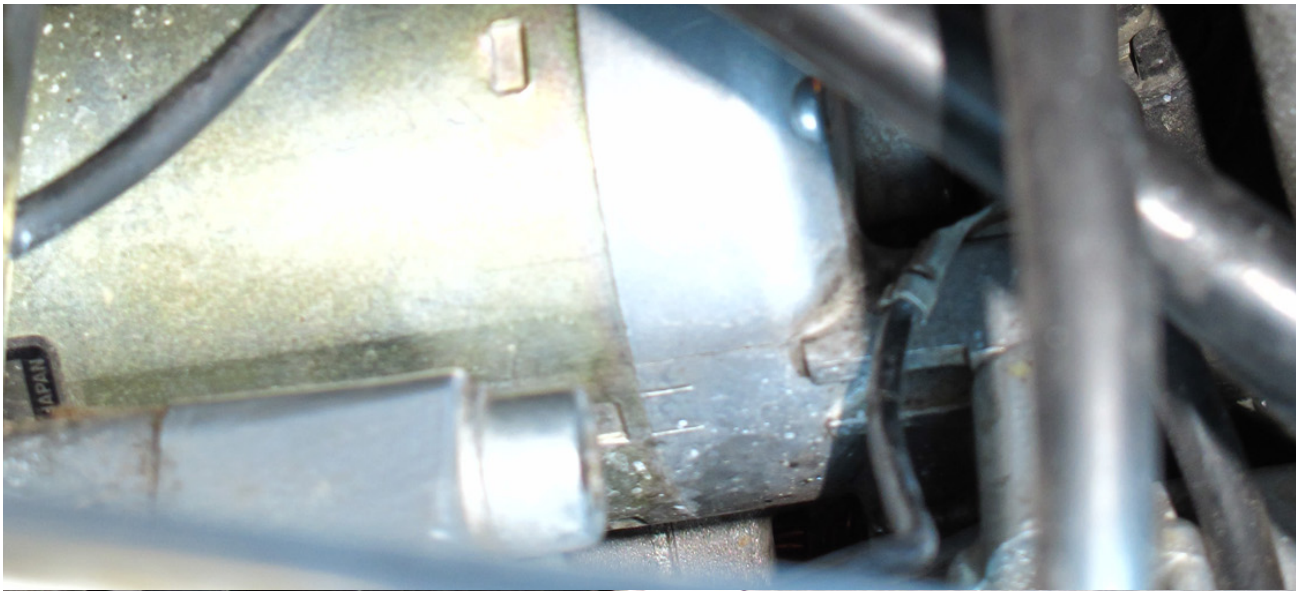
6. Starter Relay with new HiCap in place on output side of the relay. Original positive cable **MUST** be attached to this terminal or there are no lights or turn signals. Other end of the output cable can be reattached to the terminal on the starter or can be insulated against accidental grounding and tied off out of the way. I chose to tie off.

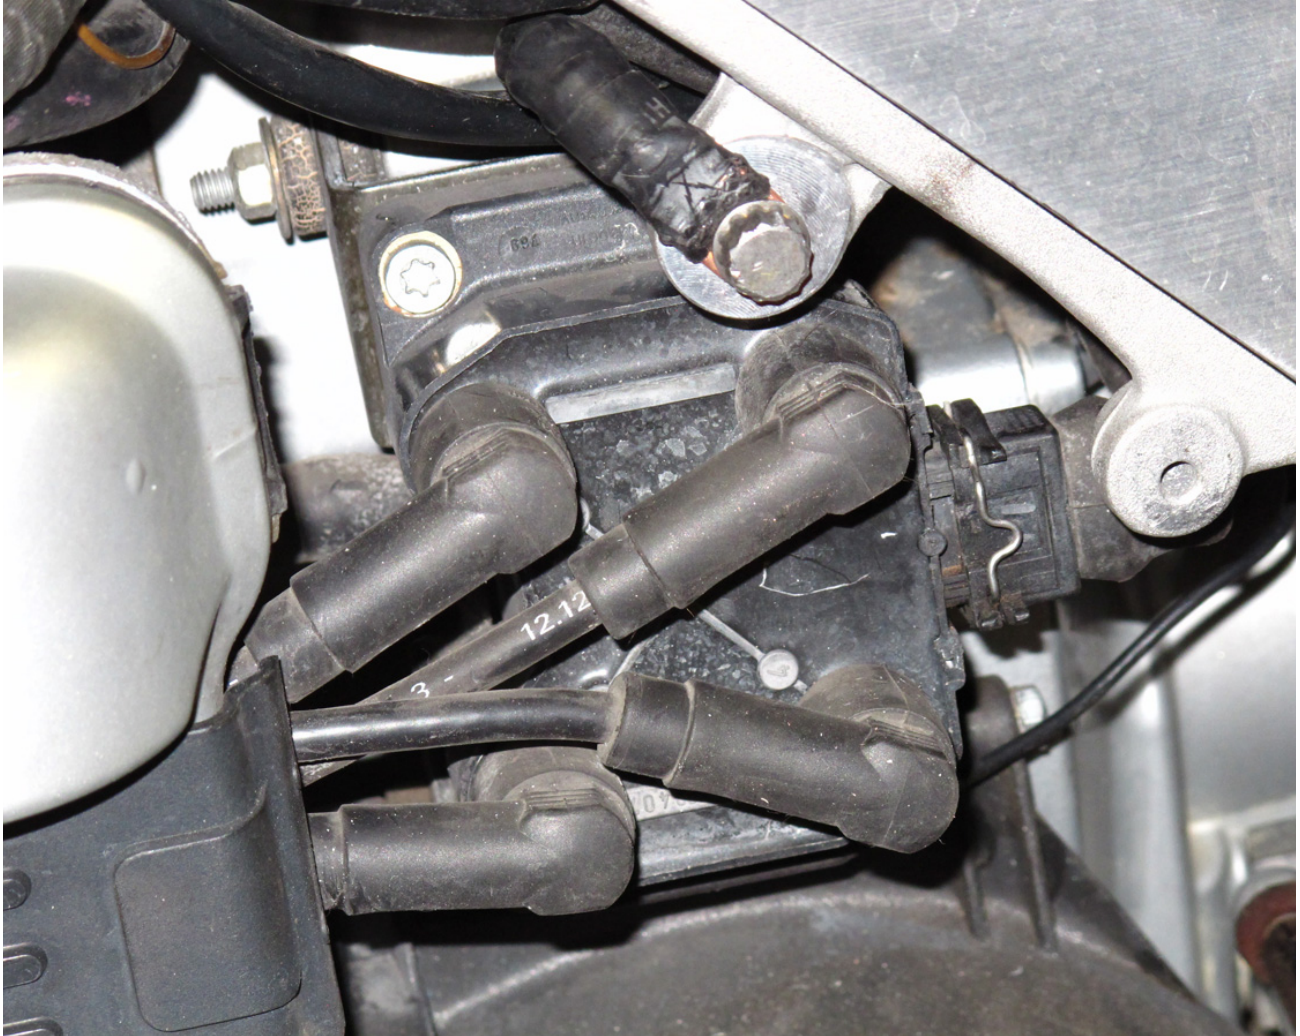
5. Coil is back in place and the ground terminal for the new HiCap negative lead is in place. (I chose to attach the new ground to the frame instead of the ground mount where the original negative leads are fastened. The original grounds are still in place.

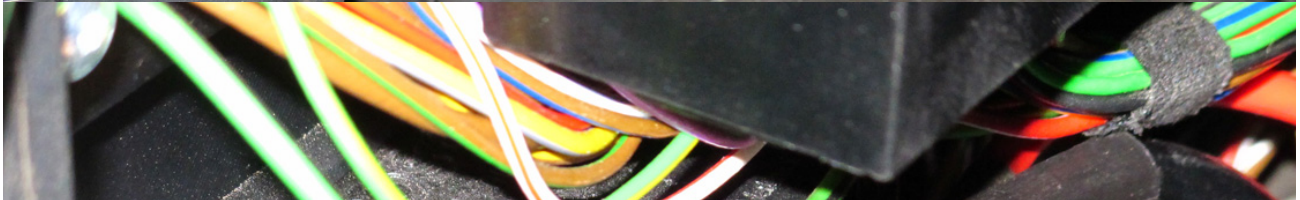
7. Control tower with covers back in place and two new HiCap leads tie-wrapped to the wiring loom. As is obvious, there's room to add the two new positive leads and still fasten everything back in place.
